PHYSICAL NEEDS

PHYSICAL NEEDS ASSESSMENT

SHAKER LANE SCHOOL

EMG Project #: 104477.13R-004.017
Date of Report: July 15, 2013
On site Date: June 19 and 20, 2013

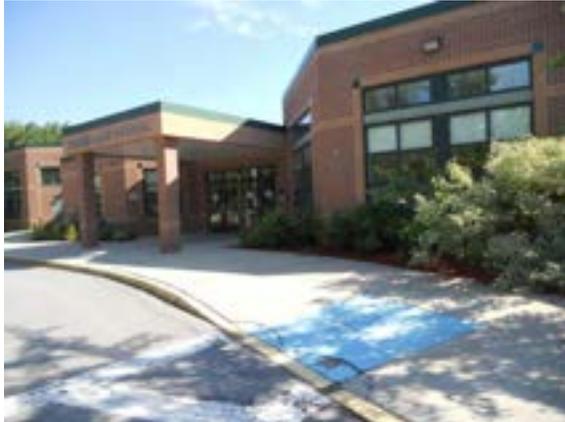
Photo #1:	Front entrance and deteriorated curb cut
-----------	--

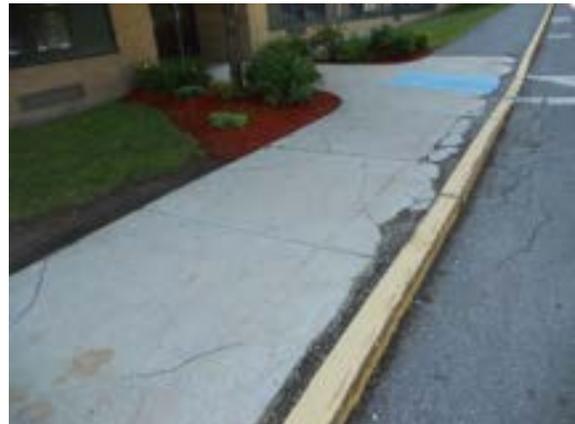
Photo #12:	Cracked and deteriorated sidewalk along west side of building
------------	---

5.2	209287	G2031 Remove & replace concrete sidewalk	25	25	0	1152	SF	\$8.96	\$10,322	\$10,322																				\$10,322
5.5	209337	G2016 Property ID Sign, painted wood, install new	0	0	0	2	EA	\$3,000.00	\$6,000	\$6,000																				\$6,000

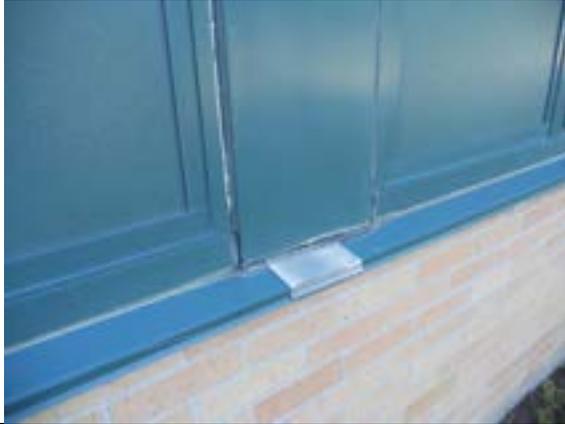
Photo #13:	Deteriorated sealant at spandrel panels
------------	---

6.3	209351	B3021 Replace plexi-glass skylight 20 to 30 sf	20	15	5	25	SF	\$33.15	\$829						\$829															\$829
6.4	209402	B2011 Caulking, polyurethane, 1/4"x1/4", remove and replace	15	14	1	1600	LF	\$3.84	\$6,144		\$6,144															\$6,144				\$12,288

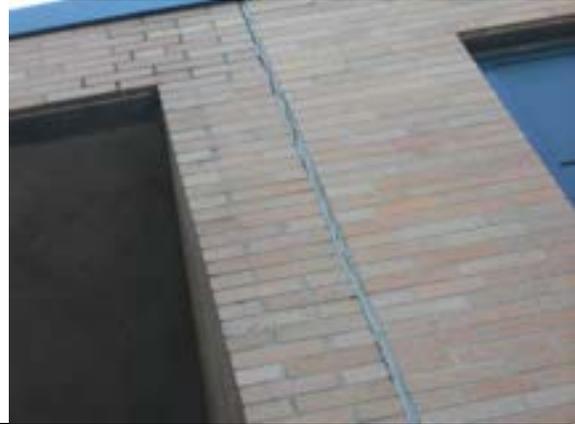
Photo #14:	Deteriorated expansion joint
------------	------------------------------

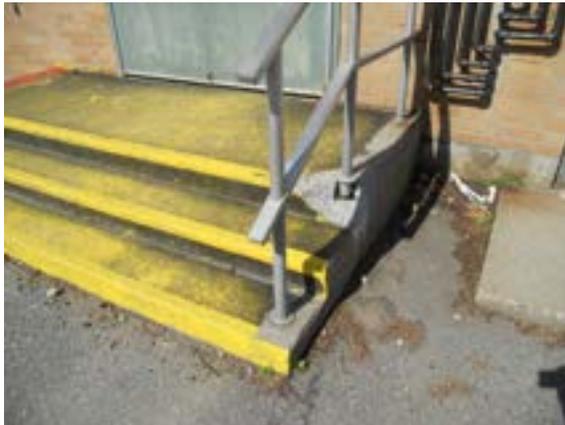
Photo #15:	Deteriorated concrete at rear steps
------------	-------------------------------------

6.5	209418	B1015 Remove and replace steel pipe railings, 3 rail galvanized,inc paint	0	0	0	47	LF	\$90.88	\$4,271	\$4,271																				\$4,271
6.5	209417	G2035 Cast-in-place concrete stair repair	0	0	0	75	LF Nosing	\$6.75	\$506	\$506																				\$506

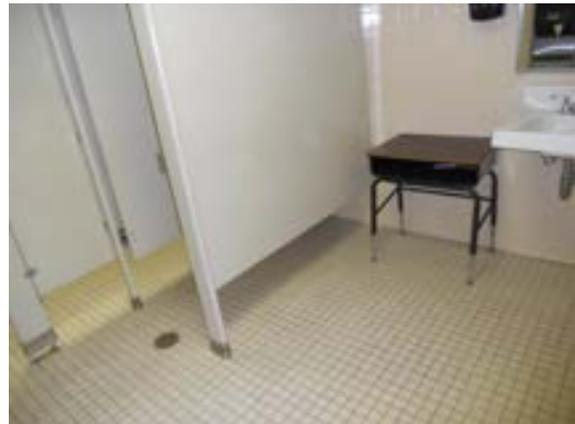
Photo #18:	Common area restroom with no drain pipe insulation
------------	--

3.2	209273	C1031 ADA, Wrap drain pipes below accessible lavatory	0	0	0	3	EA	\$65.00	\$195	\$195																				\$195
3.2	209272	D1011 Add ADA raised markings at elevator control panel, jambs and hall buttons	0	0	0	2	Floor	\$550.00	\$1,100	\$1,100																				\$1,100

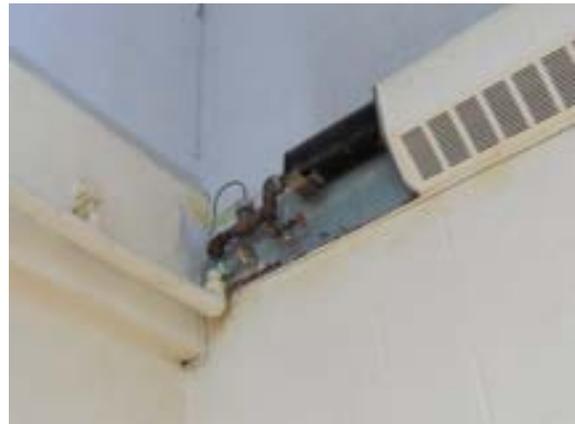
Photo #24: Wall mounted radiant heater with missing cover

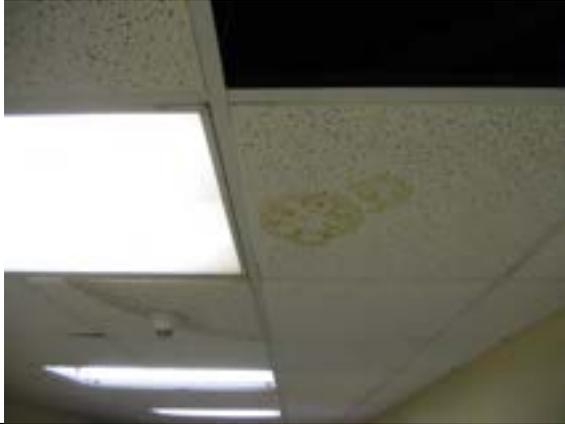
Photo #25:	Water staining
------------	----------------

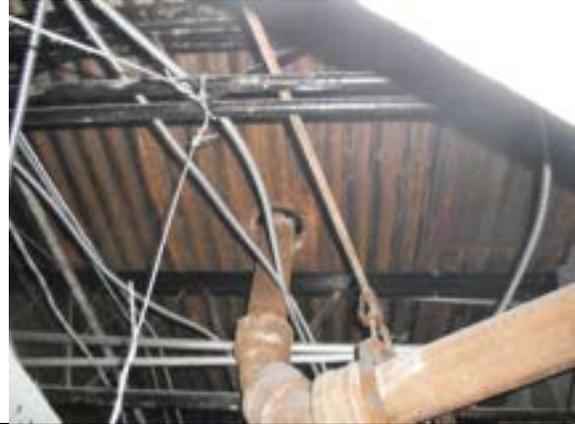
Photo #26:	Drain line above stained ceiling tiles
------------	--

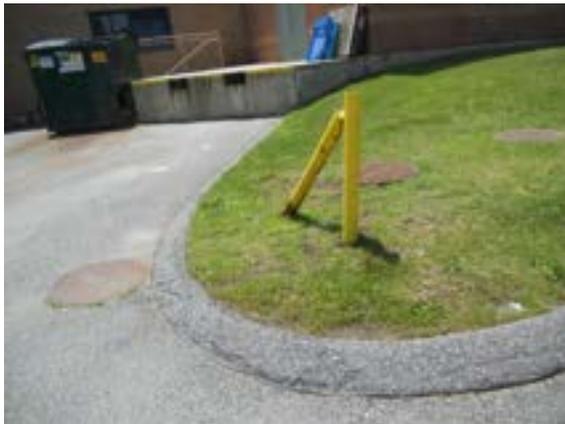
Photo #41: Loading dock with damaged bollards

5.5	209513	G2023A Steel bollards, install, 6" dia	25	24	1	3	EA	\$885.00	\$2,655		\$2,655																			\$2,655
5.5	209329	G2041 Remove and replace 4-foot chain link fence	25	24	1	50	LF	\$22.12	\$1,106		\$1,106																			\$1,106

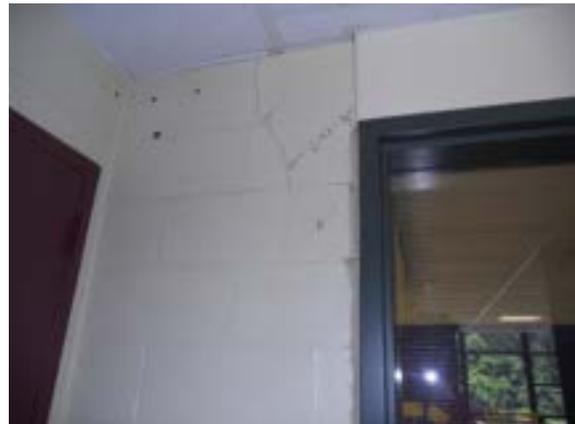
Photo #42: Settlement cracking at second floor of stairwell adjacent to generator room

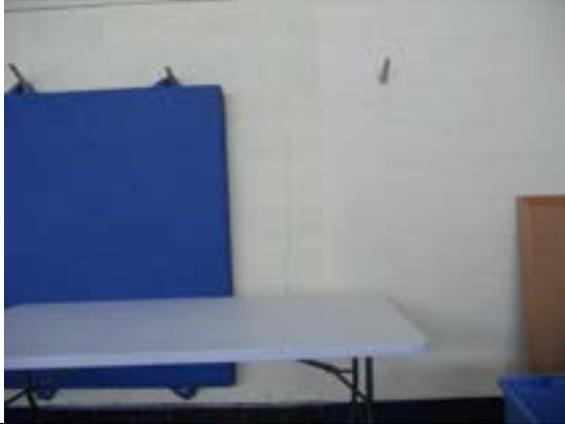
Photo #43:	Cracking in gymnasium
------------	-----------------------

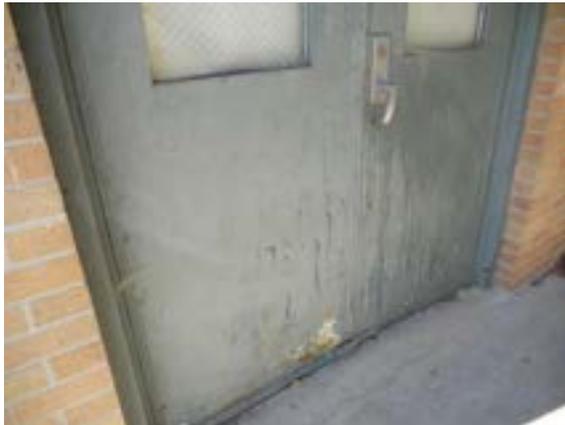
Photo #51:	Rusted and deteriorated service door
------------	--------------------------------------

6.6	209433	B2031A Replace 6'-0" x 7'-0" steel double door with frame and hardware	35	34	1	1	EA	\$2,573.50	\$2,574		\$2,574																			\$2,574
6.8	209517	C3011 Replace ceramic tile, low walls	50	49	1	40	CSF	\$980.00	\$39,200		\$39,200																			\$39,200
